**Miles City Hatchery  
Pond Liner Repair  
FWP# 7113103  
ADDENDUM NO. 2**

**Air Line Details**  
 Miles City Hatchery

**RE: Miles City Hatchery  
Pioneer Technical Services Project No. 16636**

Addendum #2 Pond 31 Repairs  
#7113103

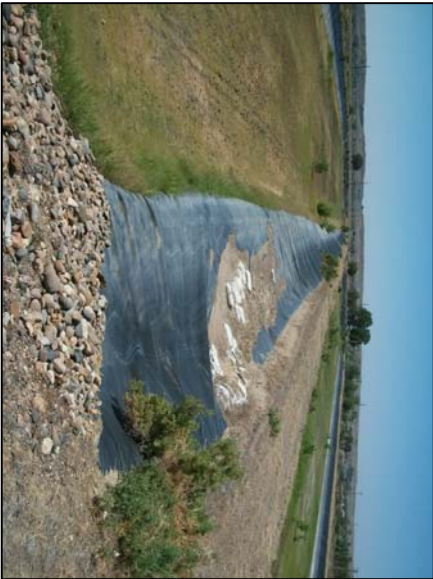
Pond 31 side view

A. Remove sandbags (shown in photo) from slope and dispose.  
Cut Liner at 150 foot mark to allow for folding down.  
Fold down liner, regrade slope and install geoconfinement system as described on sheet 3.  
Transition slope to existing ground and then re-weld liner.  
Rekey top of liner and restore roadway.

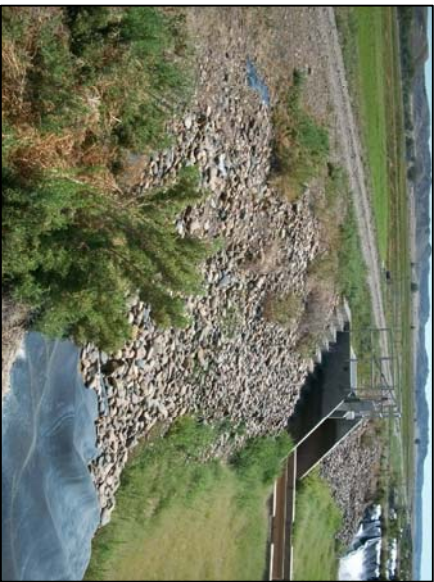
Pond 31 end view

B. Refer to Section A-A and preperation notes.  
Remove liner entirely from end cutting at existing corners.  
Regrade and install Geoconfinement system as described on sheet 3.  
Install new liner and weld to existing liner at corners.  
Reinstall existing termination strips.  
Rekey top and bottom and restore roadway.
